# Living With the Stehekin River in the aftermath of the December 2025 Flood

*A report by Paul Bakke<sup>1</sup>*

*February 2026*

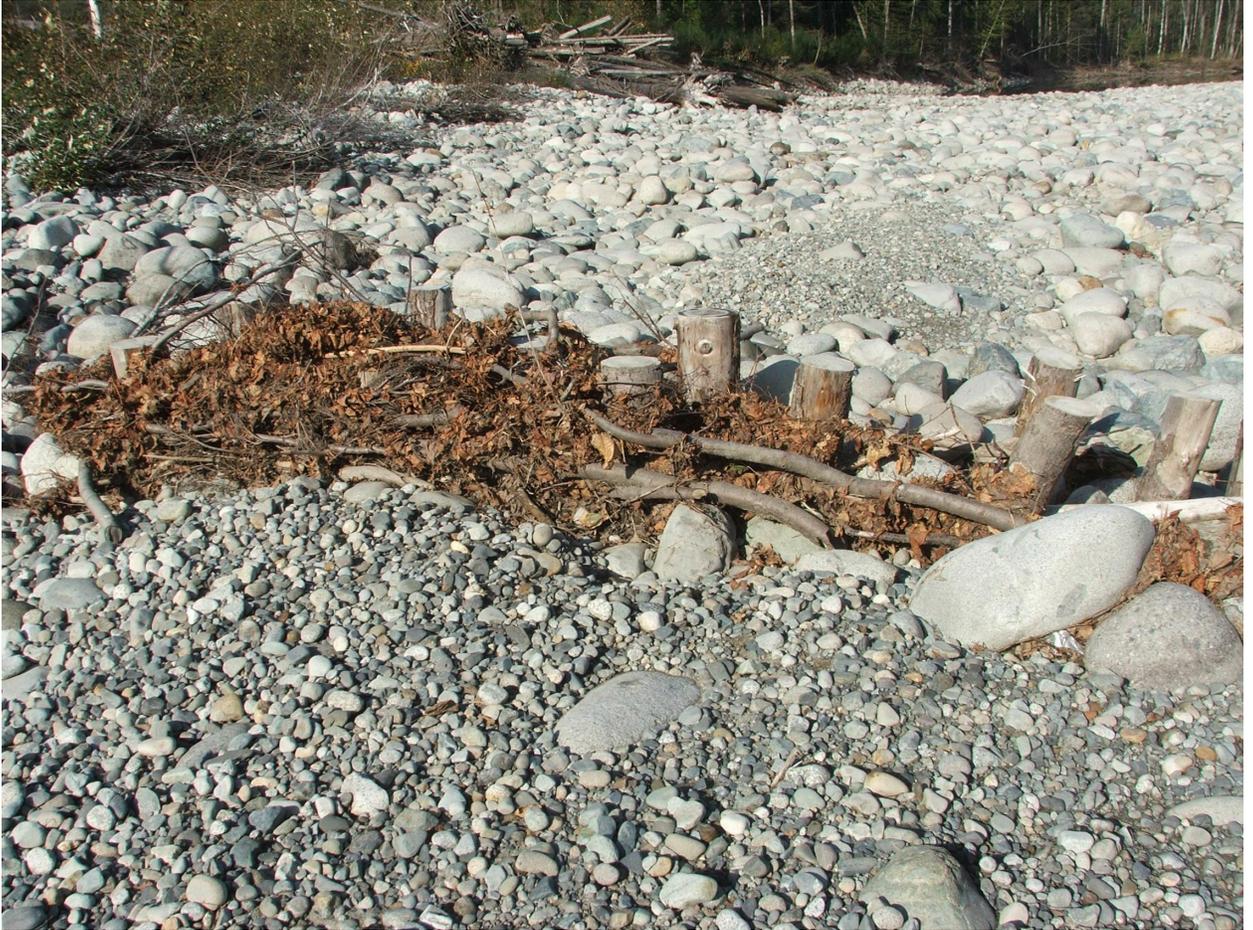
Flood fences are low-profile structures consisting of rows of short piling, perpendicular to the flow, built on the gravel bars and shallow or dry edges of the channel.

(Photo: Flood fence on the Skykomish River, Washington)

During high water, flood fences catch or strain out woody debris and large cobbles, but are low enough that they don't cause the flow to back up the water or cause scouring. Instead, they create high spots on the channel edge, coaxing the main flow back into the middle of the channel. By putting in enough of these and starting well upstream of the eroding area, it is possible to modify the channel shape, giving it a narrower, deeper central area surrounded by higher gravel bars on the edges. This creates a more concentrated flow in the middle of the channel that keeps more sediment moving, and steers it more efficiently past the widened area that was filling in with sediment, and past the nearly 90-degree bend at the road washout/dike failure site (RM 5.9) that the flow could not negotiate without putting extreme pressure on the side channel, the now-failed dikes, and the road.

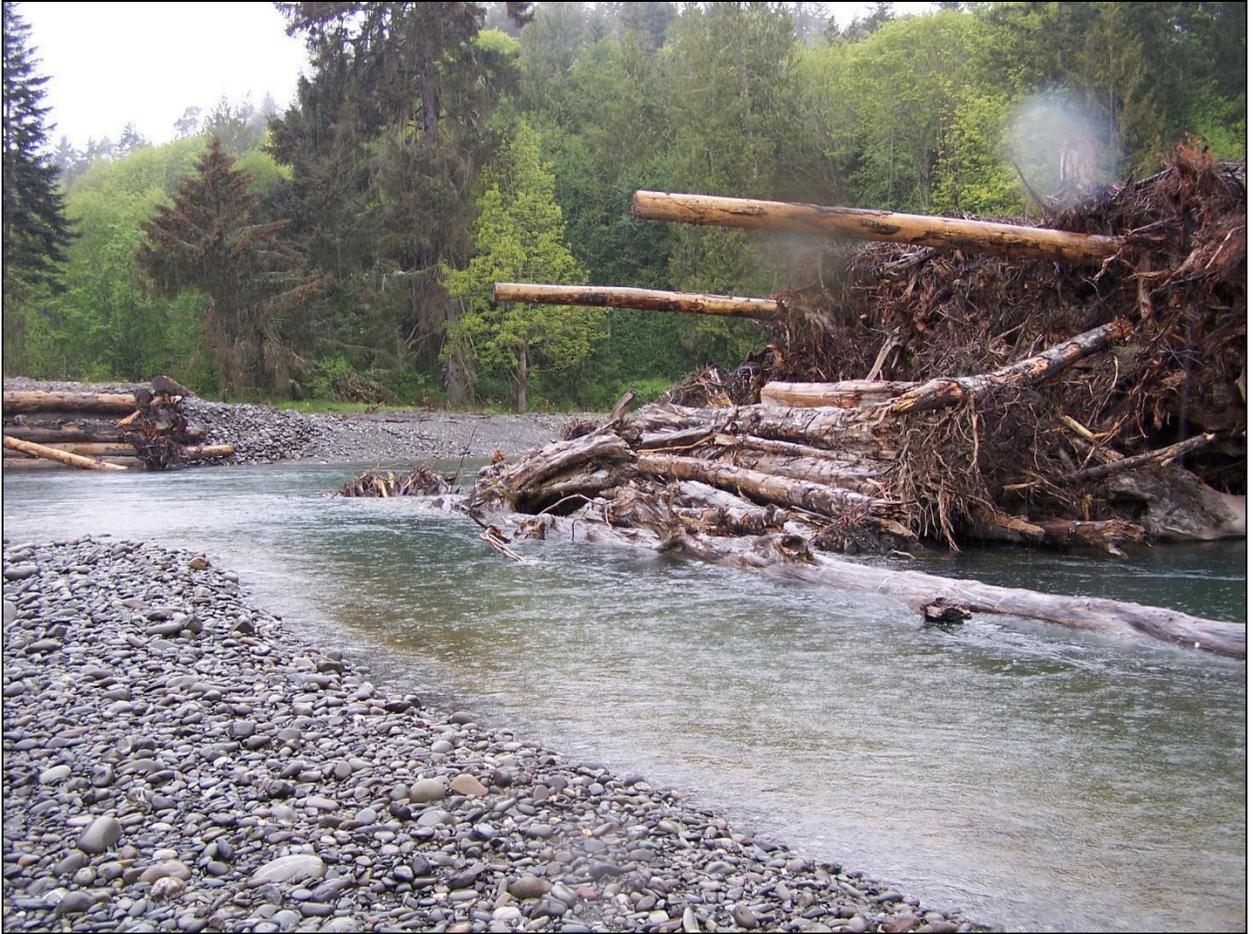
(Photo: engineered logjams on Elwha River, Washington)

An engineered logjam is just that – an artificially-constructed log jam, anchored and bound together so that it won't move, designed to keep a central channel scoured for holding most of the flow, while routing the sediment load through the reach, instead of depositing within the reach.

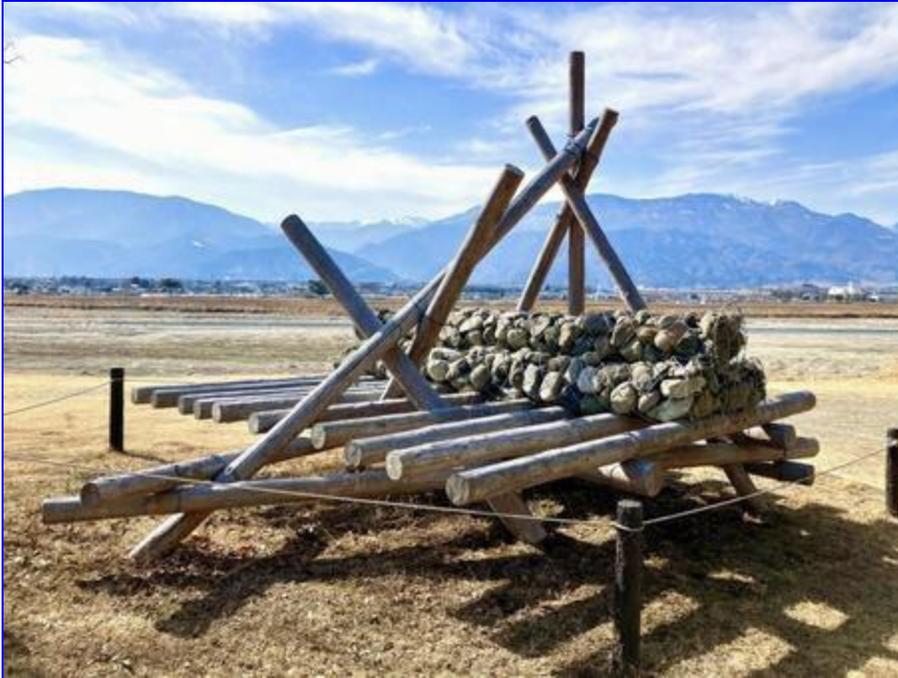
There are other less-expensive versions as well, such as the “Seigyū” structures traditionally used in Japanese rivers. These are log pyramids weighted by bags of rocks.

(Photo: Seigyu, <https://en.rattibha.com/thread/1640177574180708352> )

These are designed to be easily rebuilt if they break up, and allow the option of placing more of them, or moving existing ones, as the river responds.

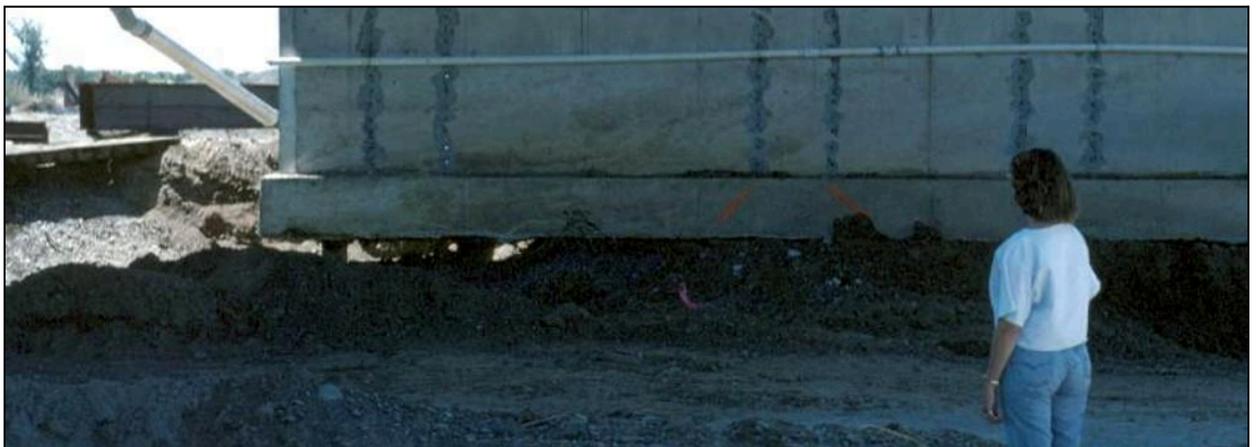
(Photo: Bridge pier undermined by migrating knickpoint from dredging)

Dredging on this scale would create a “knickpoint,” that is, a short, steep zone of high energy dissipation and turbulence in the river channel that migrates upstream as it erodes the streambed. When the bed erodes, the height of the riverbanks increases, which destabilizes them. This destabilization spreads upstream, possibly for miles.

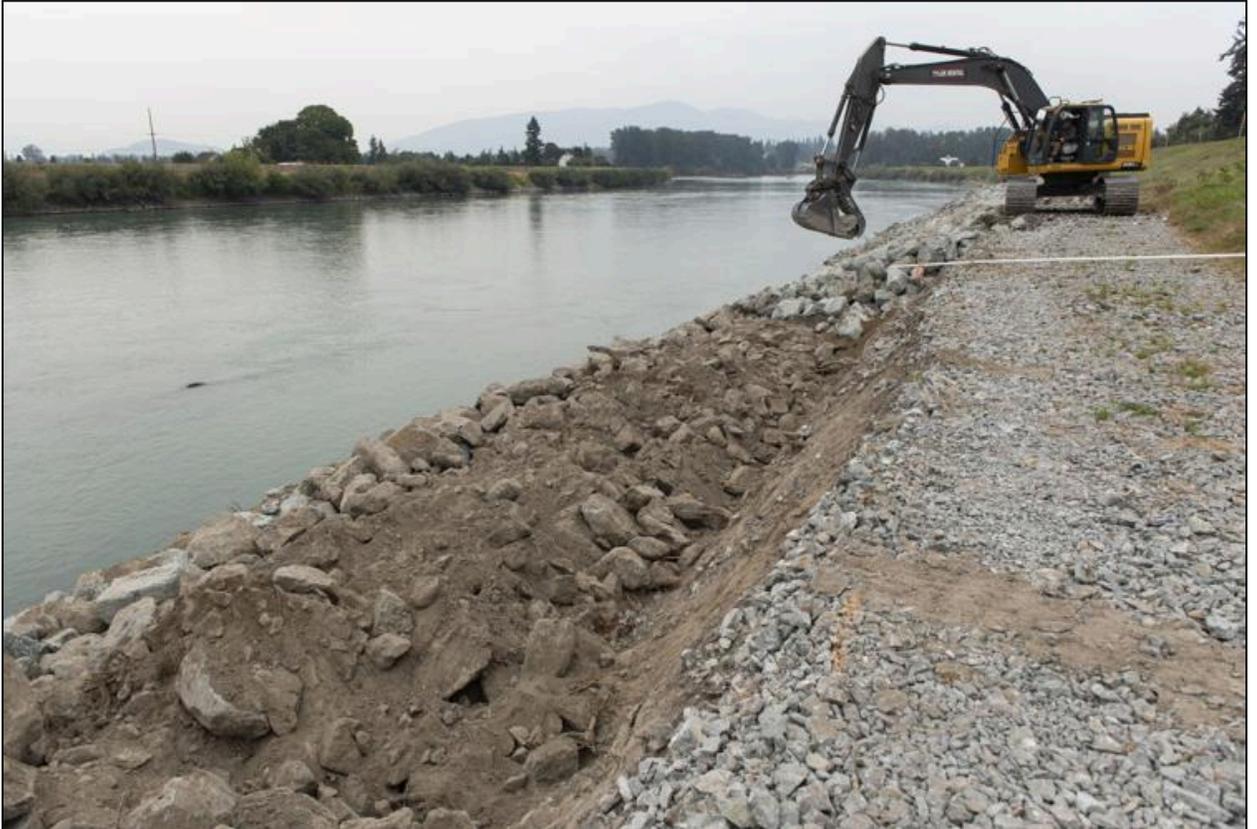
(Photo: dike repair at work along Skagit River, August, 2023. Source: goskagit.com)

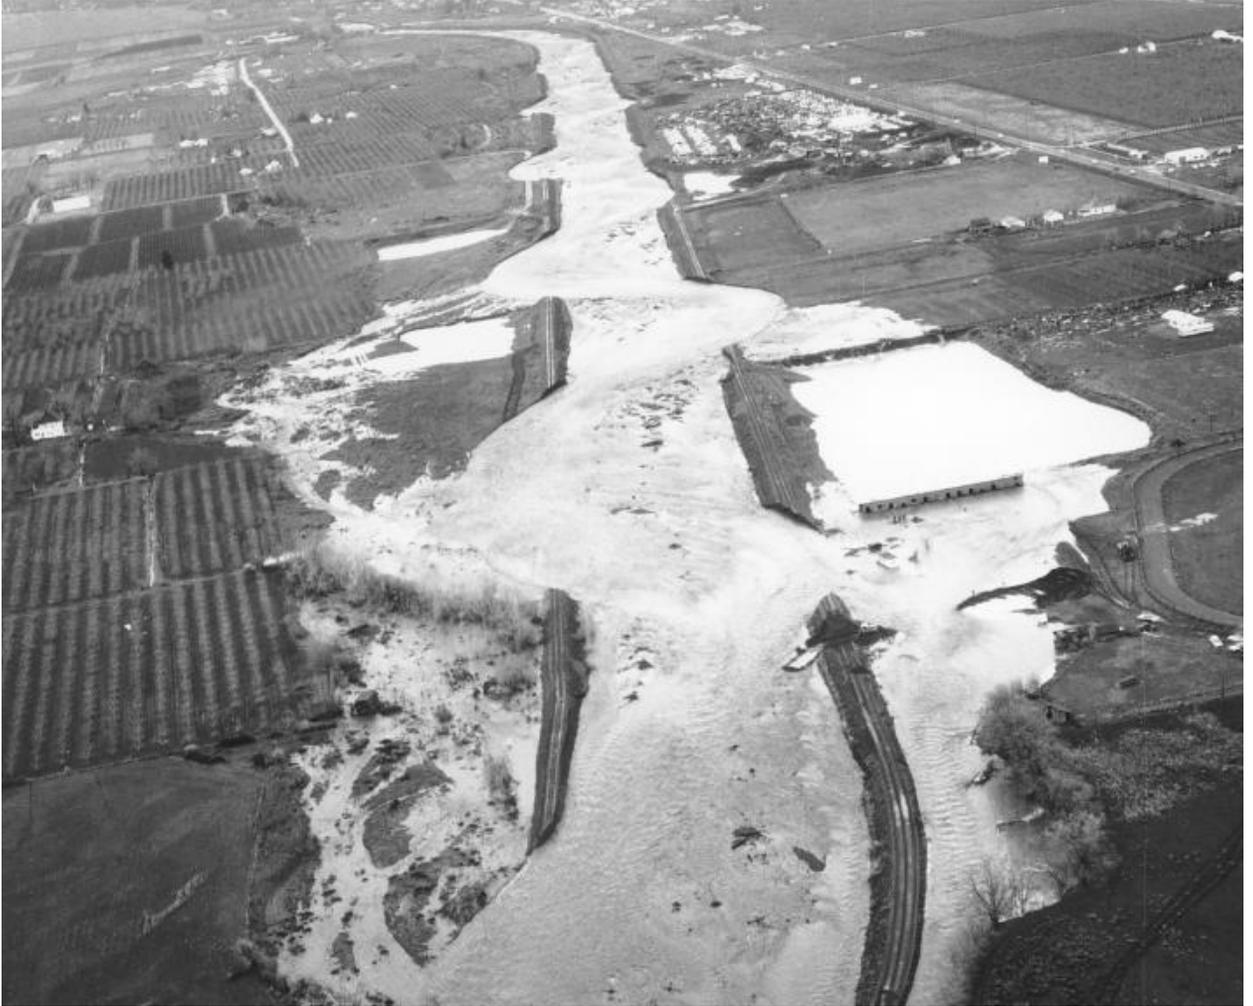
(Photo: Walla Walla River near Milton Freewater, Oregon, 1964 flood. Notice that the dike has failed in a way that re-established the natural meander pattern of the river.)

Below is an impressive aerial photo of the Walla Walla River demonstrating how the river can break a dike in order to reestablish its natural configuration. Recall that straightened rivers are not stable.

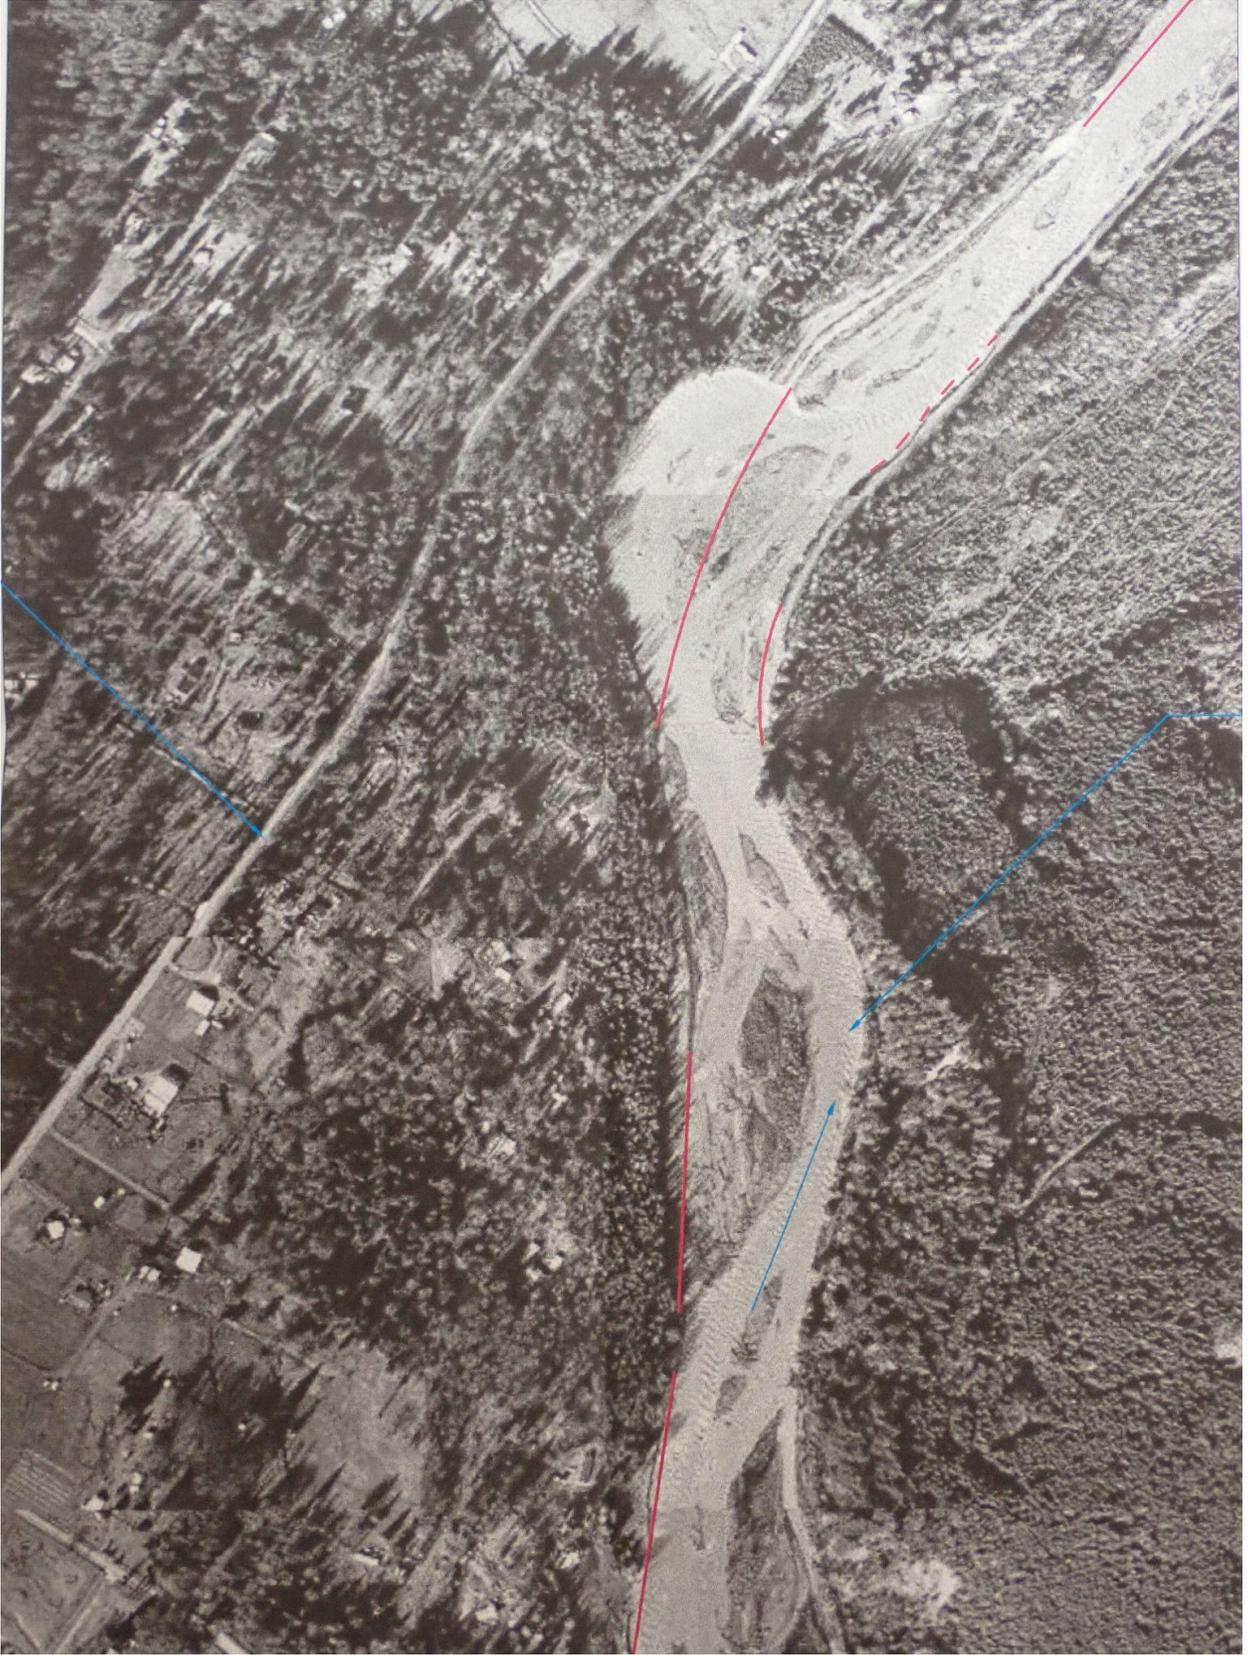
(Photo: Puyallup River after the 1996 flood. Red lines show dike failures.)
